COMMONWEALTH OF KENTUCKY  
BEFORE THE PUBLIC SERVICE COMMISSION

KENTUCKY POWER COMPANY D/B/A	)	
AMERICAN ELECTRIC POWER	)	
	)	
_____	)	CASE NO. 96-446
	)	
ALLEGED FAILURE TO COMPLY WITH	)	
COMMISSION REGULATION 807 KAR	)	
5:006, SECTION 25(4)(d)	)

### UTILITY ACCIDENT INVESTIGATION REPORT

Attachment C  
Photographs of Accident Site

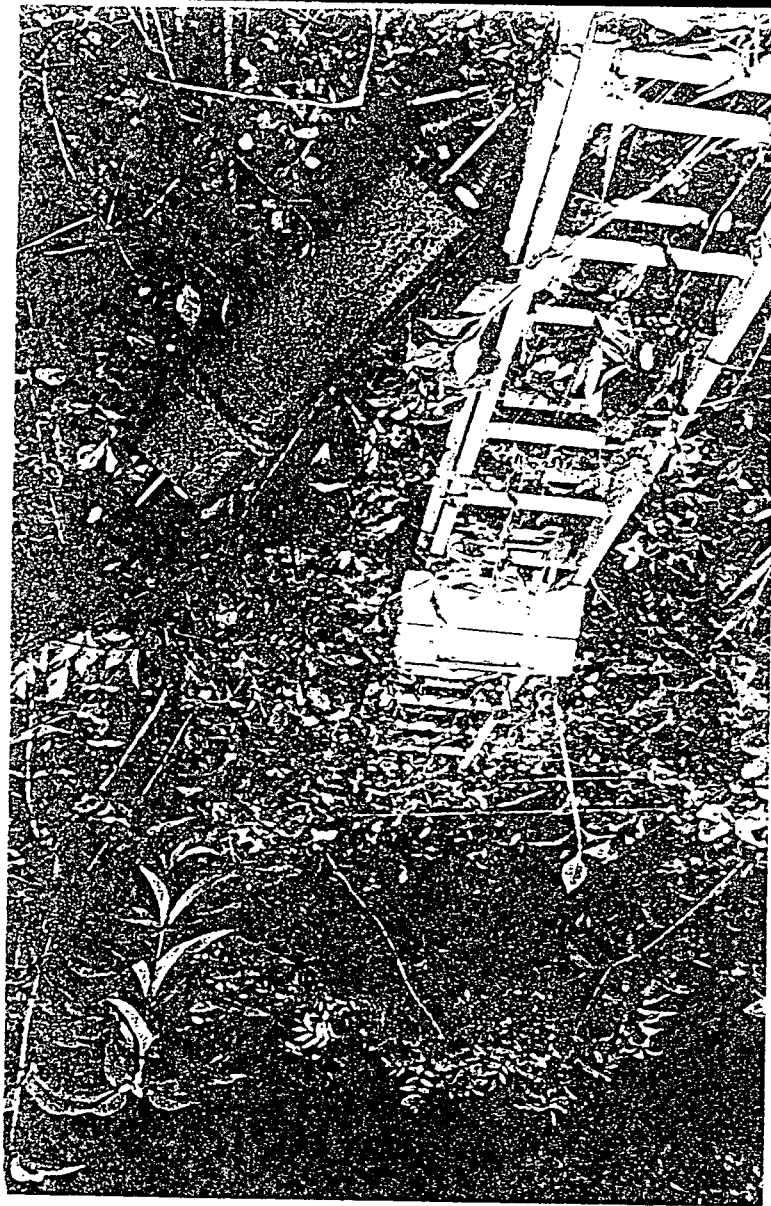
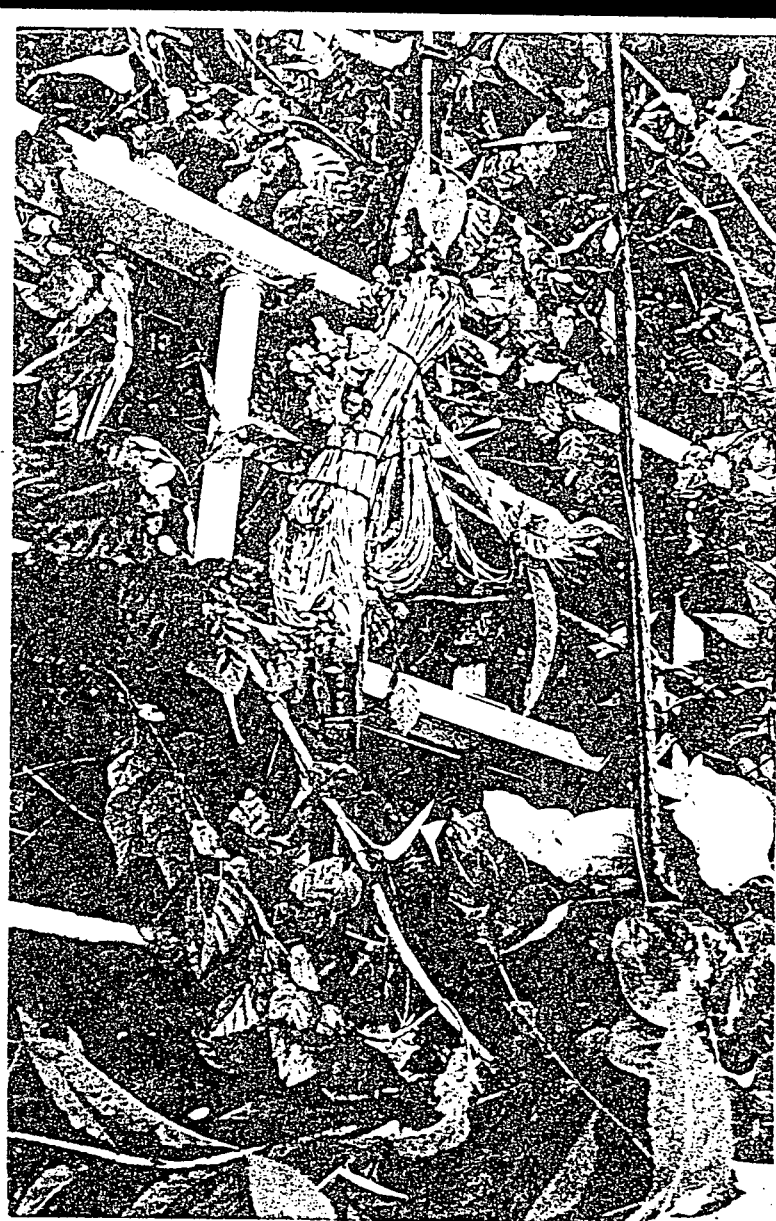
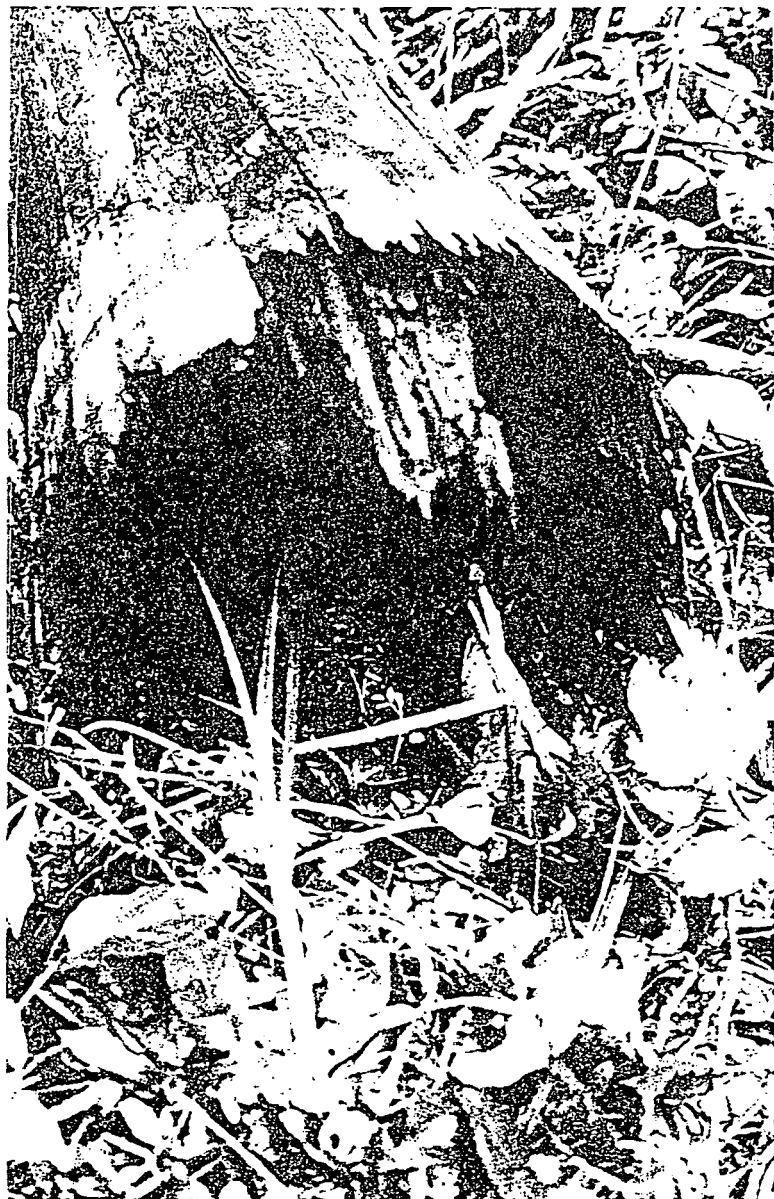
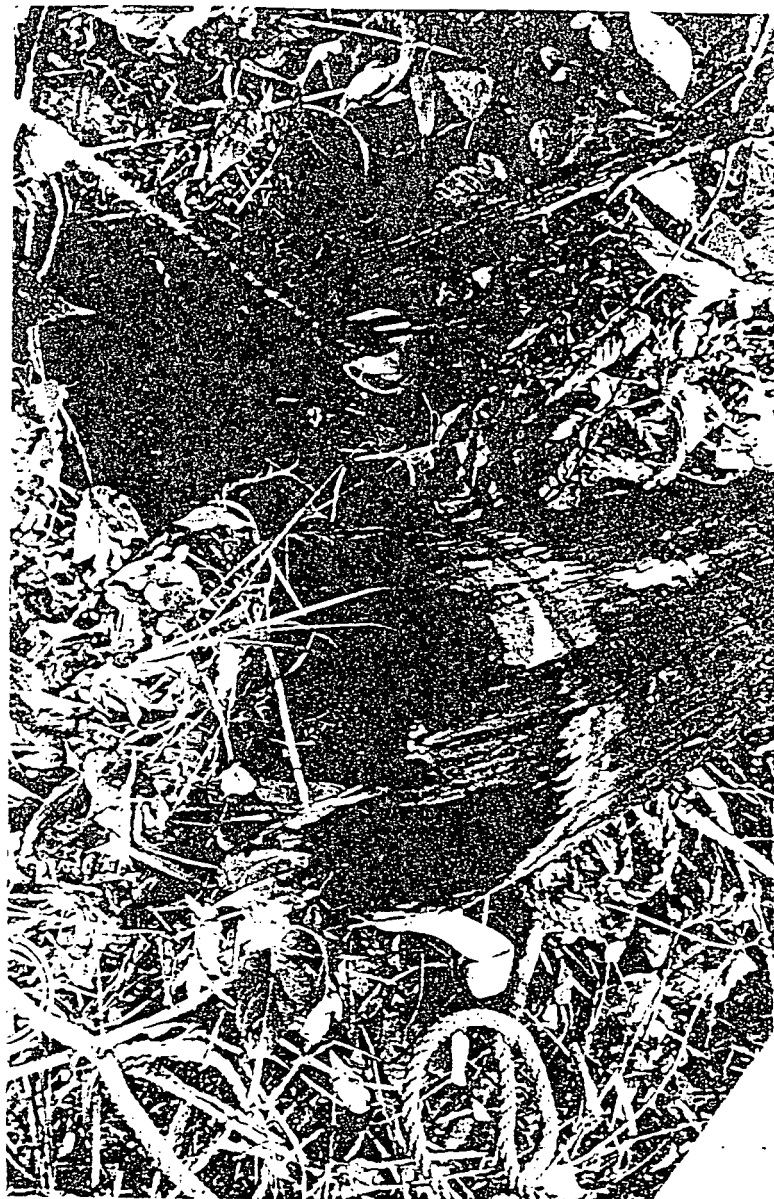
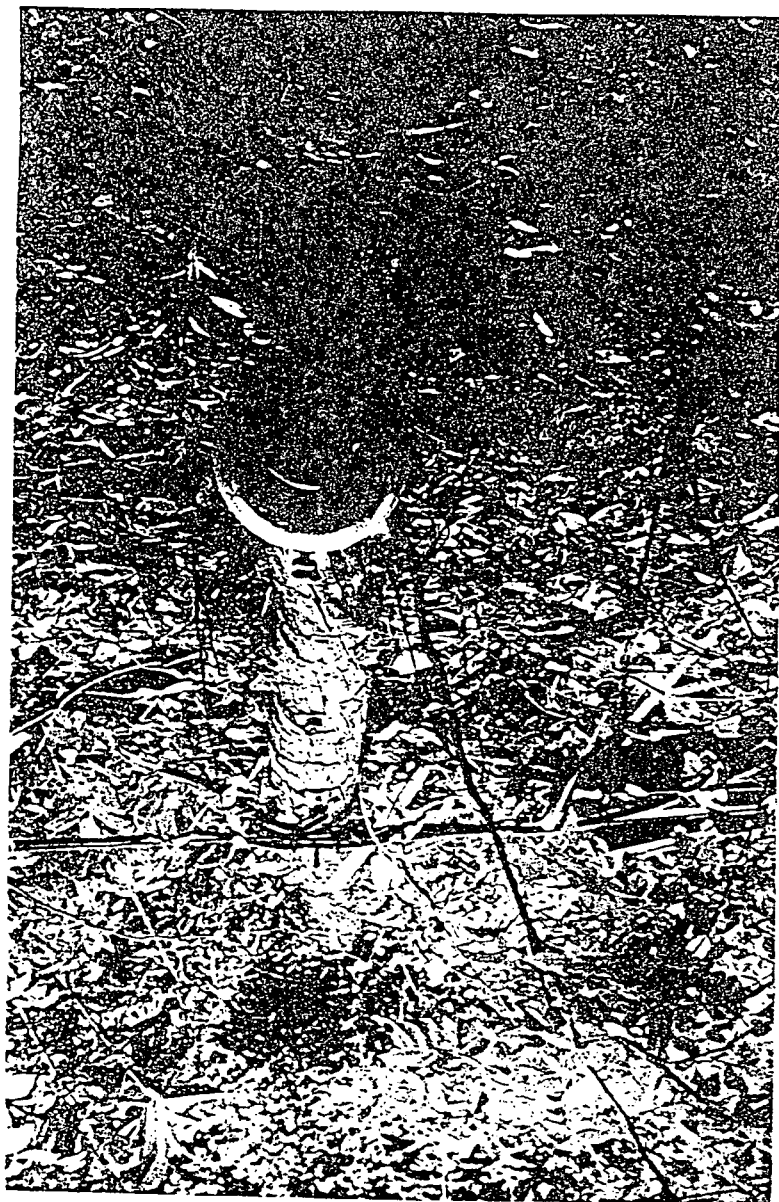
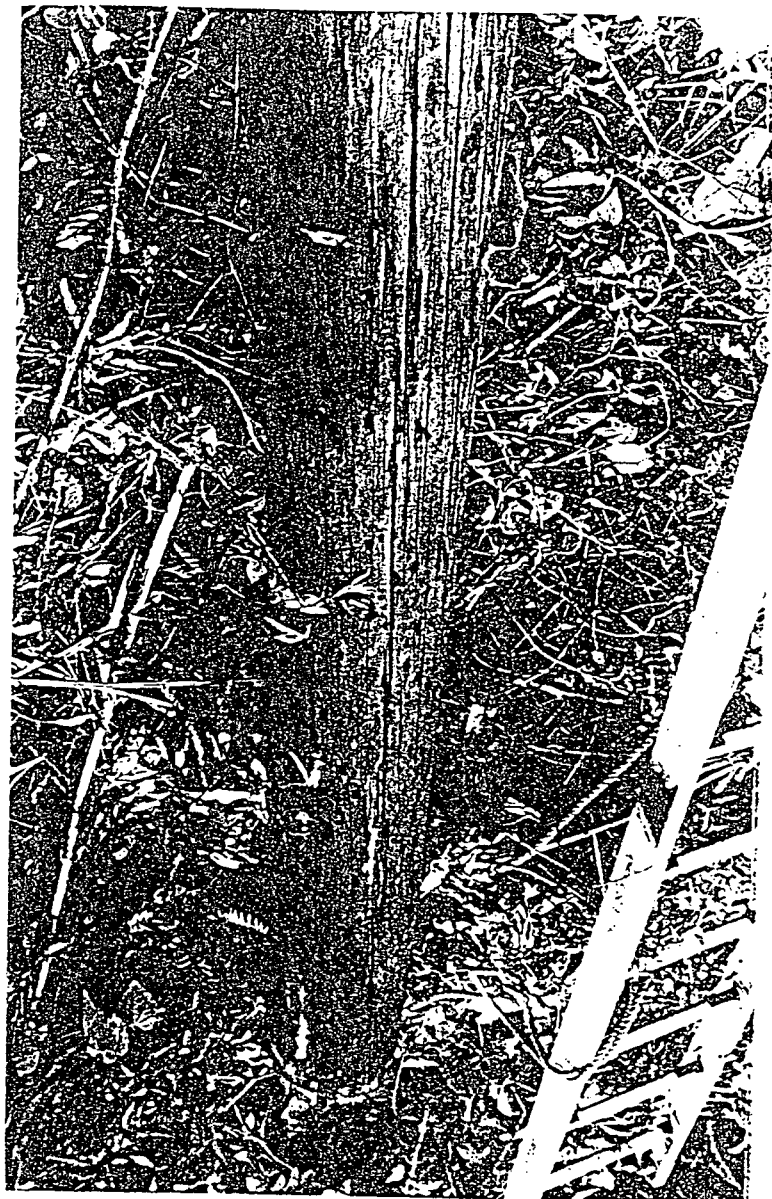
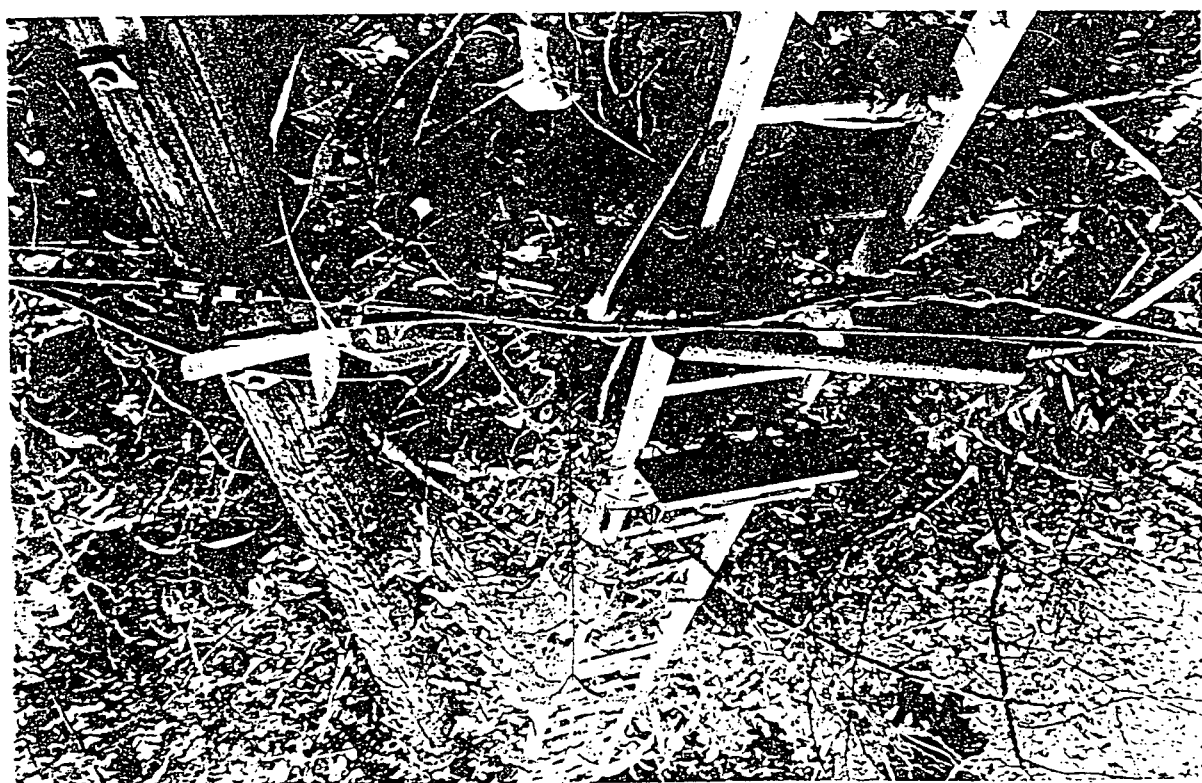
The pole was a 35' class 6 installed in June 1945 with a single phase #4 cu. primary and neutral conductors. The pole also had two telephone cables attached. The pole appeared to be 6' 3" in the ground. Last pole inspection was on 10/11/93. The pole was rotten at the ground line and was covered with red ants. The pole appeared to be hollow at least four feet up from the ground line.

It appeared the primary conductor was broken loose from the insulator when the pole fell and contacted a pine tree approximately twelve feet away. The conductor fell striking Ellis or the ladder he was standing on.
